FOLLEY LANE TRANS PENNINE TRAIL

In conjunction with Yorkshire Water, The Trans Pennine Trail team appointed KBI to regenerate the Folly Lane stretch using our KBI Flexipave material in order to make the path accessible for horse riders, and also to improve the overall access for pedestrians and cyclists.

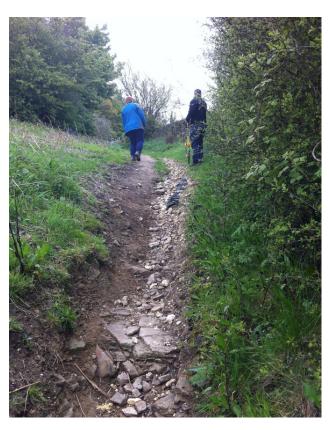
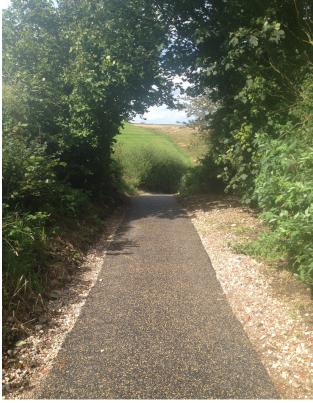
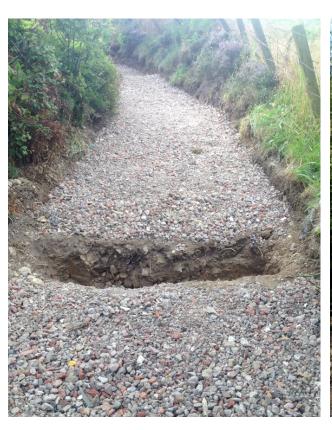
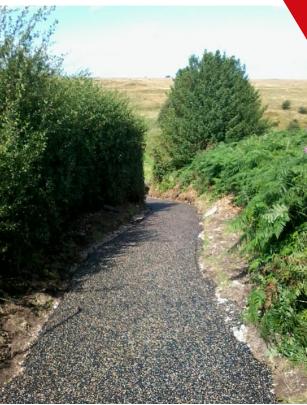
Having widened the existing path, baffles were dug in to the steeper inclines to allow water to effectively recharge back into the ground after penetrating through the KBI Flexipave. The baffles (circled) also reduce the migration of the stone used within the sub-base, helping to ensure a stable path.

Once dug, each baffle was filled with KBI Flexipave, eliminating the possibility of the channel becoming clogged whilst still allowing the free movement of water. The vertical sections of Flexipave then bonded with the finished top surface, locking the path into the ground.

In order to ensure that the porosity of KBI Flexipave could be exploited, the sections of the path that ran over steep inclines involved baffles being dug in to the ground prior to the material being laid. The baffles helped to slow down the natural desire of rainwater to run down the slope, promoting a more even distribution of rainwater directly in to the ground beneath the surface. The baffles also act as a break to minimise the migration of the stone sub-base beneath the path, ensuring a more stable overall surface.
